Warm Springs Run Site 7 Seepage Case History

Warm Springs Run Site 7

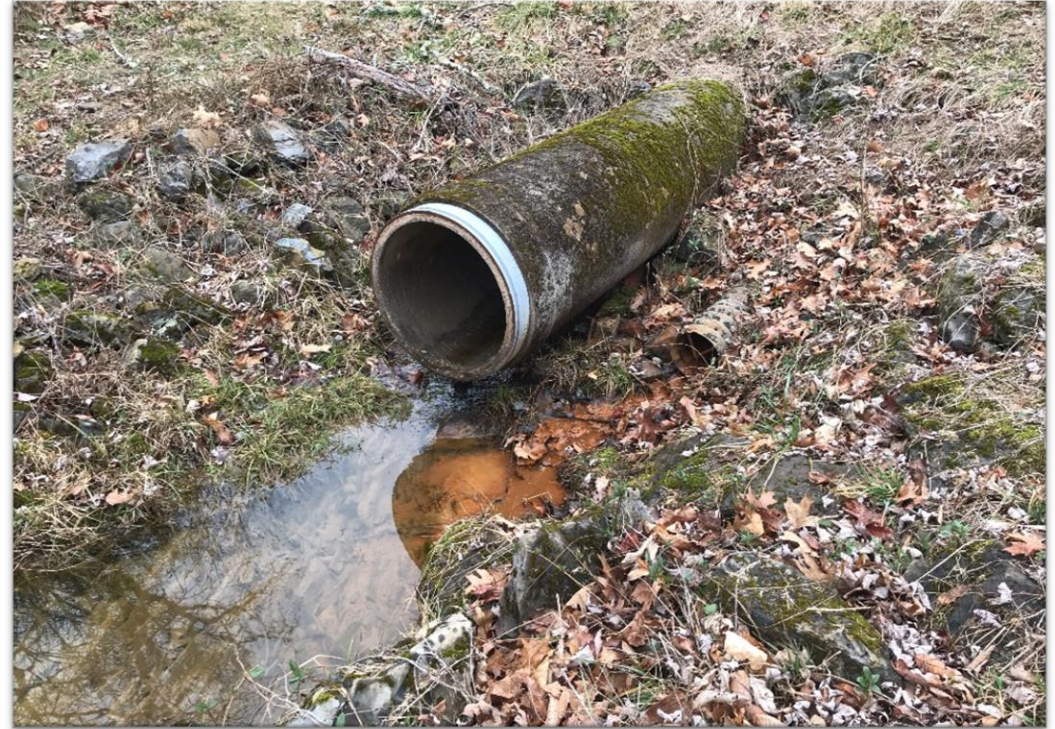
Historic Seep

- Seepage was observed shortly after construction was completed
- Flow was regularly about 1 gpm during inspections
- Inspections conducted monthly and after significant rainfall events that elevated the pool – seep continued to be monitored

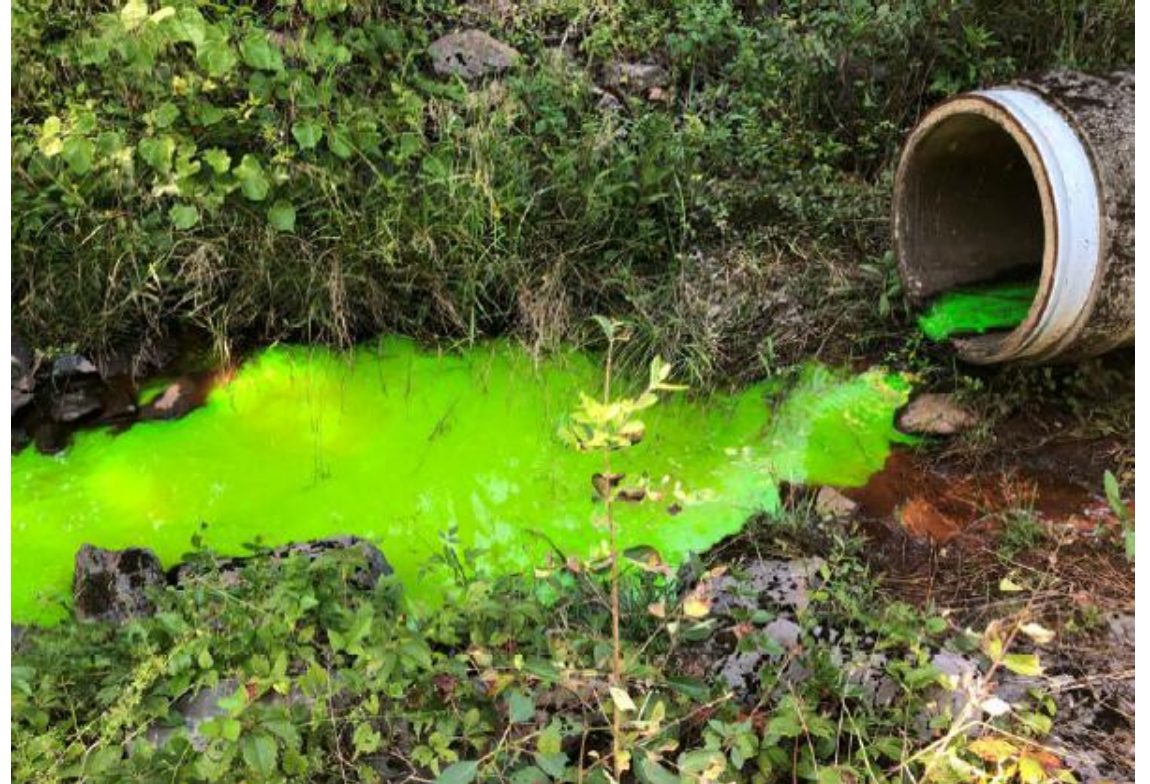
Historic Seep

- Dye trace study conducted in 2019
- One dye placed in reservoir, one dye placed in principal spillway system
- Reservoir dye detected in the first 24 hours in receptor
- Visually observed flowing from seep on day of dye placement
- Design recommendation to install filter diaphragm, consider drainpipe and cradle replacement

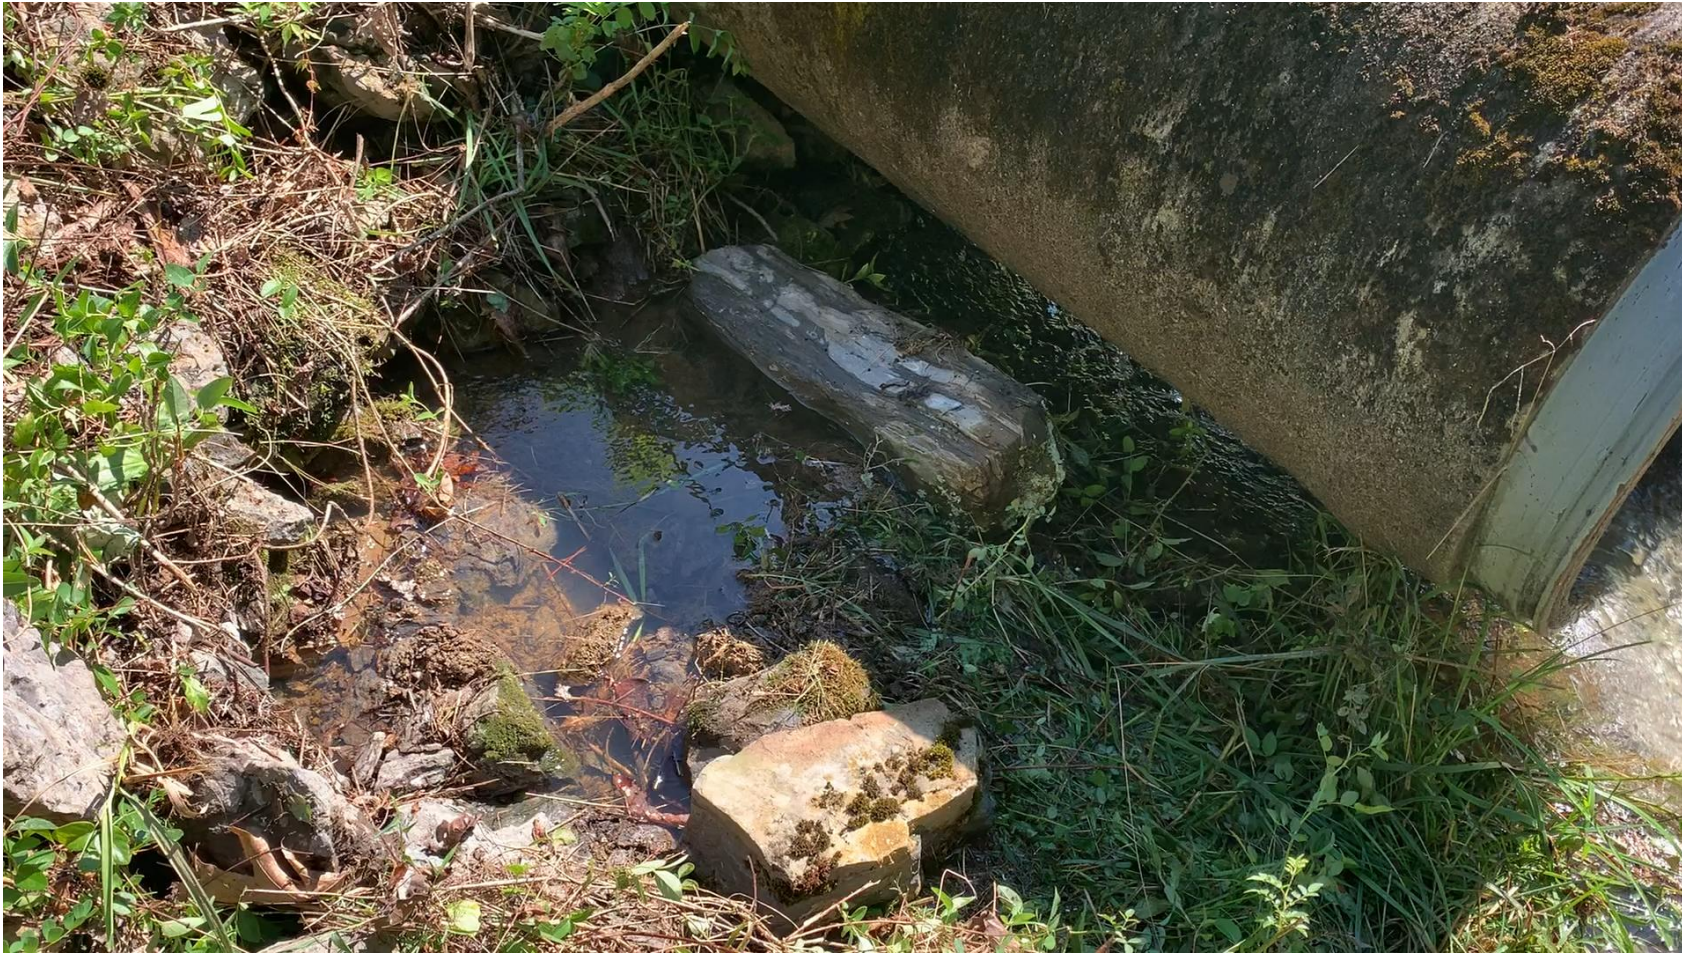
Flow From Seep

- The Berkeley Springs area received 3-4" of rain in 24-36 hours during the fall of 2021 (remnants of Hurricane Ida)
- The reservoir was approximately 1.5' below the low stage orifice (normal pool orifice) prior to the rain, but was elevated to approximately 6" above the invert of the low stage orifice following the rain
- Due to the added hydrostatic pressure, the seep became more visible and flowed at a higher rate (Estimated to exceed 10 gpm)
- Soil particles were deposited at the seep exit
 - Material resembled fine sand in its color, consistency, and texture
- Flow from the seep reduced in the days following the initial visit

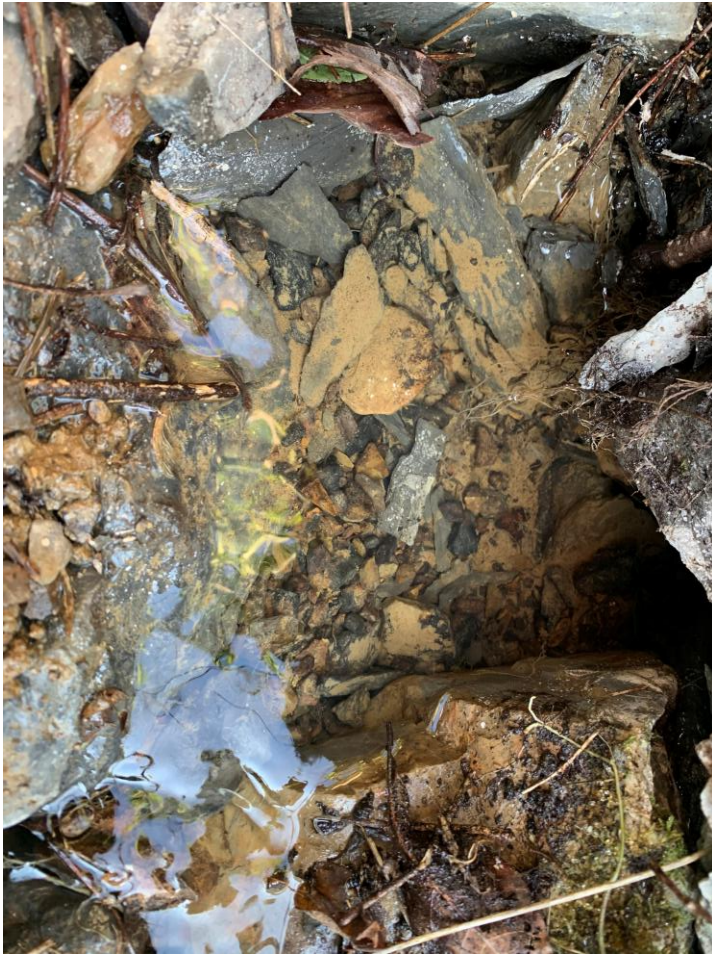
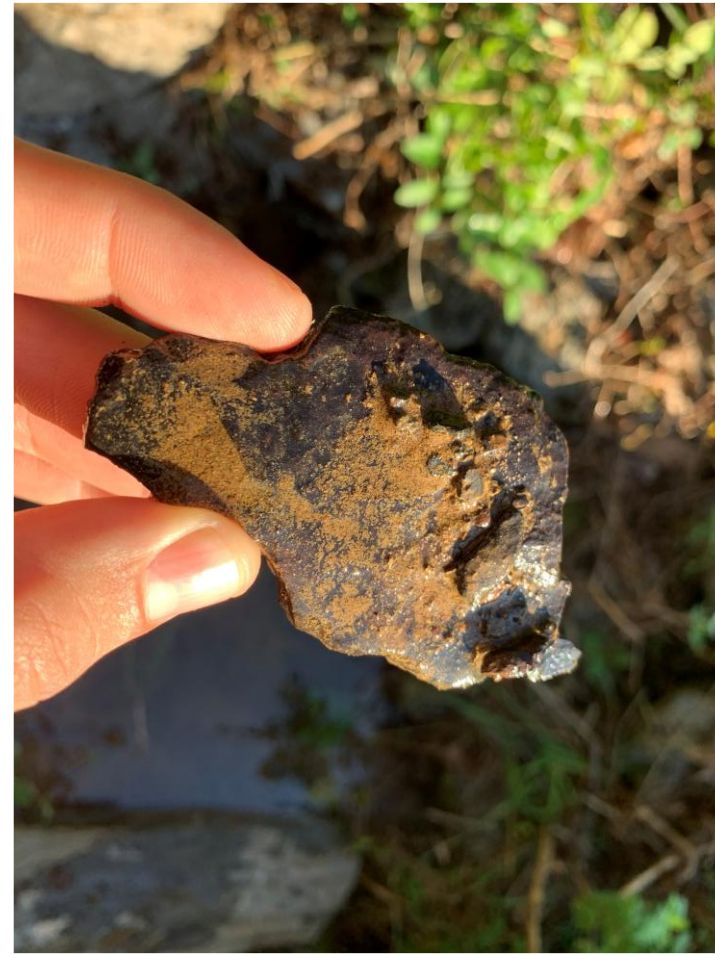
Fine Material at Seep Outlet

- A camera inspection of the principal spillway system revealed damaged concrete inside the intake riser which allowed water to flow into the principal spillway below normal pool
- The camera inspection also revealed disconnected joints in the reservoir drainpipe
- The fine sand and silt being deposited at the seep outlet indicated internal erosion of the dam
- Internal erosion can lead to piping which can create voids in the embankment
- Piping is the number one cause of non-flood related dam failures

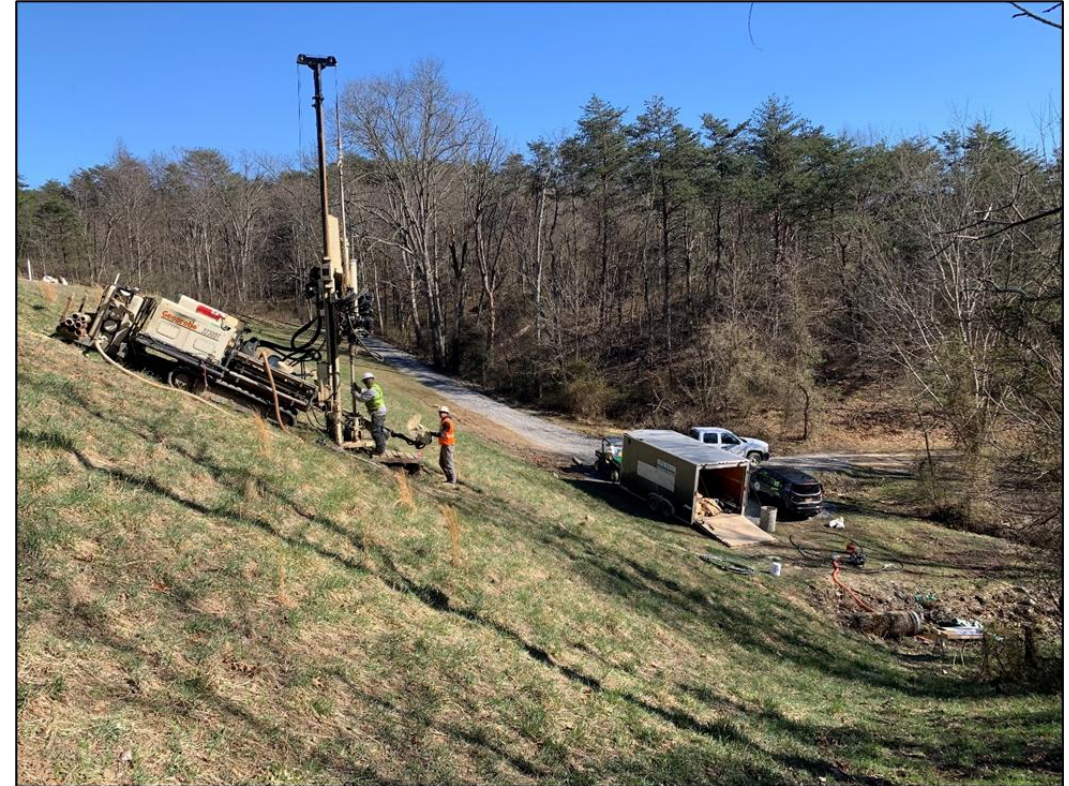
Seep Investigation

- Drilling operations began January 2022
- Investigation revealed the dam was constructed from material with high gravel content
- Particle migration believed to be possible
- Samples from drilling revealed saturated regions within the dam embankment

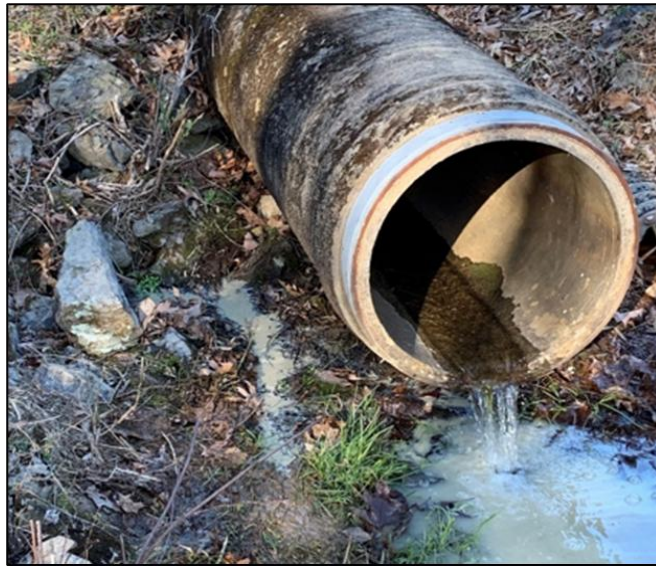
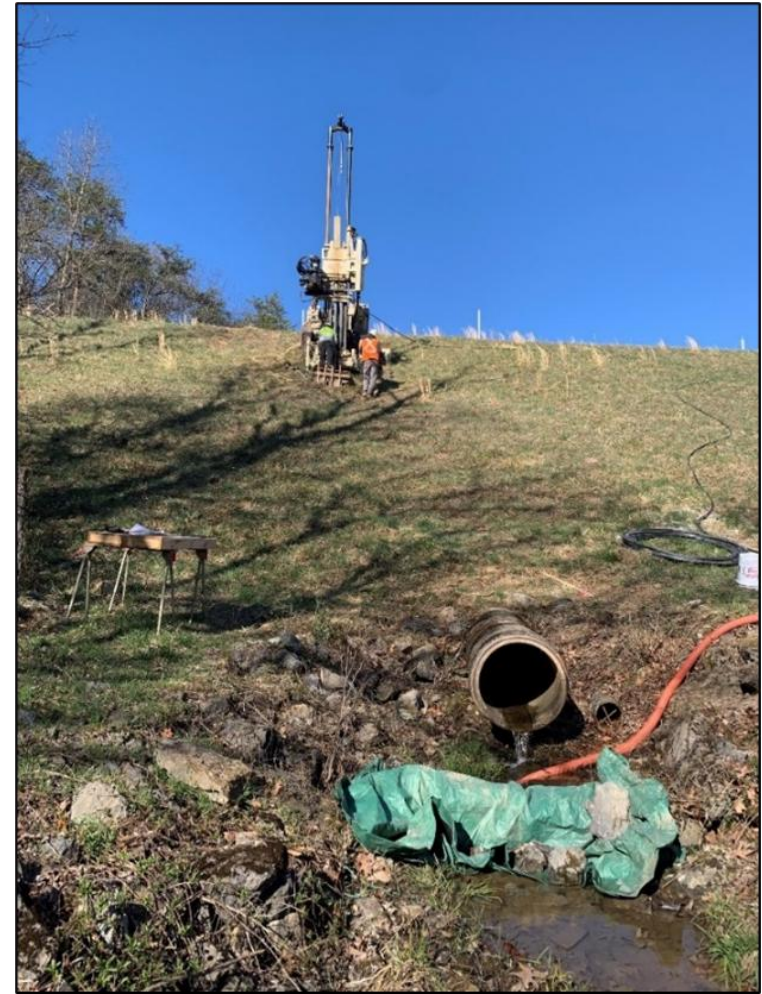
Seep Investigation

- Rock coring in hole B-04 and B-02 resulted in water flowing through the embankment and exiting around the PSW pipe
- Around 1 hour after coring began at B-04 water was observed

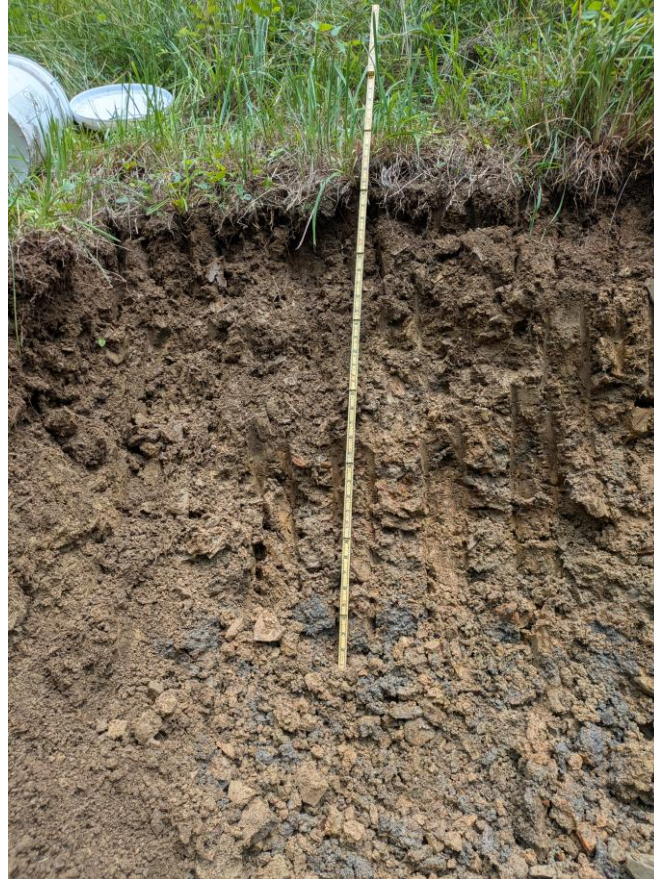
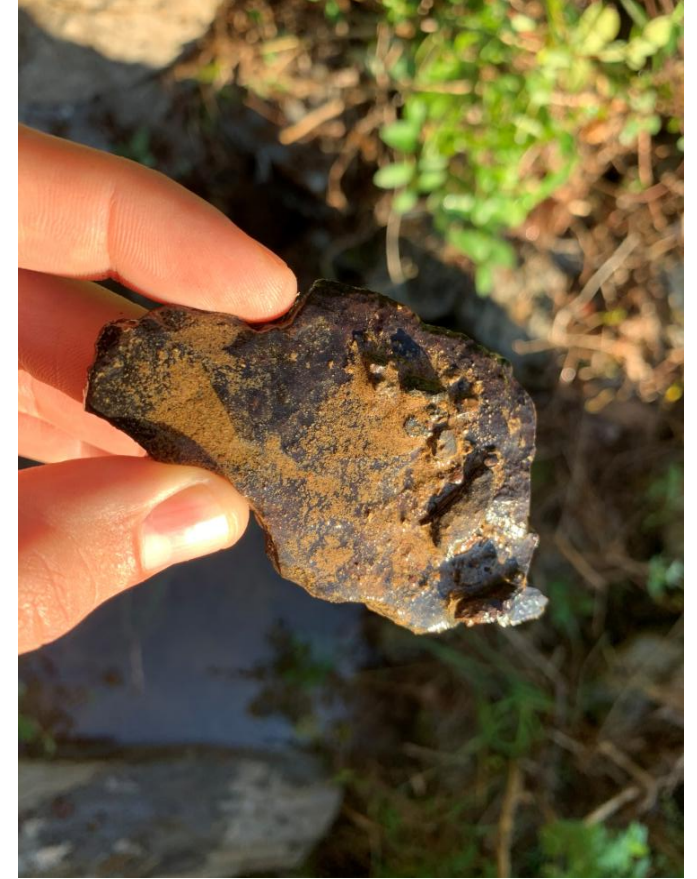
Supplemental Geotechnical Investigation

- Embankment material's fines are the same as the fines observed at the seepage location
