Texas Flood Control Dam Performing Under Pressure

By Dee Ann Littlefield, NRCS, Temple, Texas

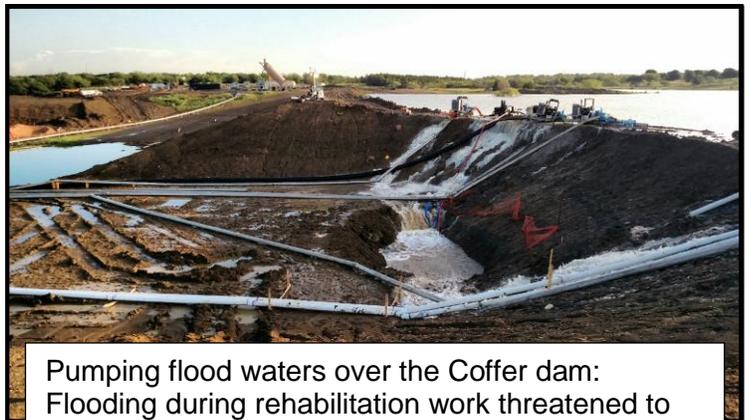
Pumping flood waters over the Cofferd dam: Flooding during rehabilitation work threatened to break the temporary cofferdam.

The cofferdam, built during the rehabilitation phase at Padera Lake, was put to the test as storm waters pressed forcefully against it. Television crews from CNN and Dallas news stations hovered overhead in helicopters, providing live coverage of the storm water surging over the top of the cofferdam. The threat was that the floodwaters would erode the dam's soil to the point it would fail.

Officials monitored the situation closely and in the end, the cofferdam held, and construction was resumed. Everyone breathed a sigh of relief, but the event did serve to highlight the importance of having floodwater retaining structures in place to protect downstream communities.

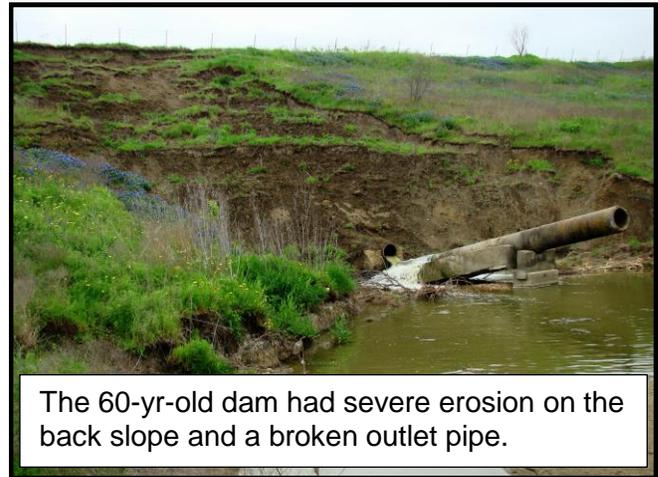
The 60-yr-old dam had severe erosion on the back slope and a broken outlet pipe.

“The main issue was the back slope of the dam was sliding because of the erodible nature of the soil,” says Tom Beach, NRCS project engineer for the project. “The soil in the new dam was treated with lime to reduce shrinking and swelling, and the exterior of the whole dam was treated with lime.

Over 6,000 tons of rock riprap was placed on the dam’s slope for reinforcement. While the dam height remained at approximately 50 feet, the biggest changes were in the outlet pipe and spillway design. The outlet pipe more than doubled in size going from 19” to 42”. The earthen spillway was replaced with a roller-compacted concrete (RCC) spillway. These measures were necessary to meet the criteria associated with a high hazard structure.

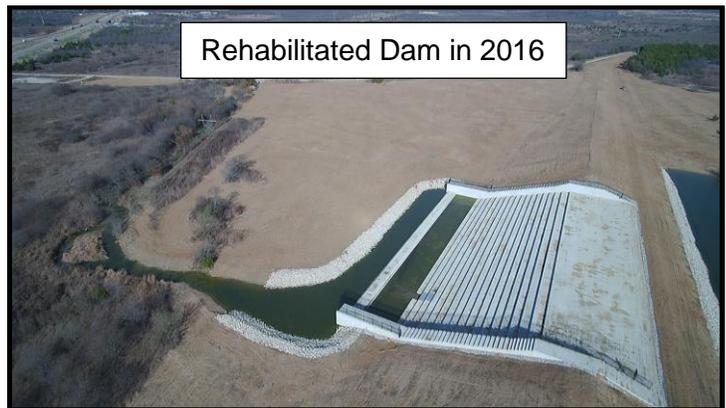
Almost 12,000 cubic yards of concrete went into the new spillway. The rehabilitation project was officially completed on December 23, 2016.
