WATERSHED STRUCTURES AND CONSERVATION PRACTICES HELP REDUCE FLOODING DAMAGES

Over \$3 million in flood damages prevented in southeast Nebraska during record rainfall event.

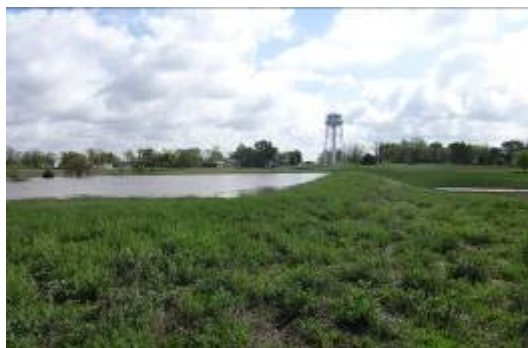
The Wilber watershed structure planned and funded by the USDA Natural Resources Conservation Service functioned as designed after Wednesday's storm event, capturing and slowing heavy rainfall to help prevent flood damage downstream in Wilber, Neb.

“There is no question in my mind the newly completed high hazard flood control structure designed by the NRCS (located) by the City of Wilber water tower saved homeowners in town from a huge mess along the creek,” Pryor said.

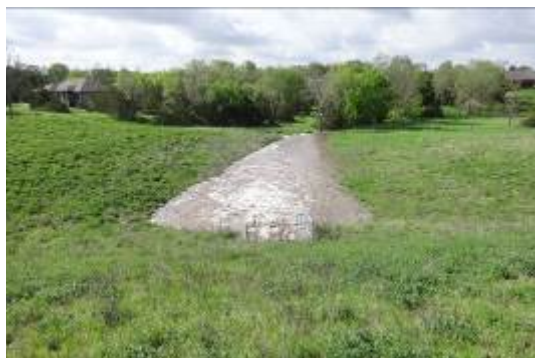
The principle outlet from the Wilber watershed structure creates a controlled, gradual release of water, which helps protect the homes and infrastructure downstream.

Flood control structures may easily go unnoticed across the landscape. But after a heavy rain event, like what was recently experienced in southeast Nebraska, these structures spring in to action. They capture rushing flood water and hold the water back allowing it to be slowly released downstream. Slowing the water down and allowing it to be gradually released reduces damage to roads, bridges, fences, cropland and other property.

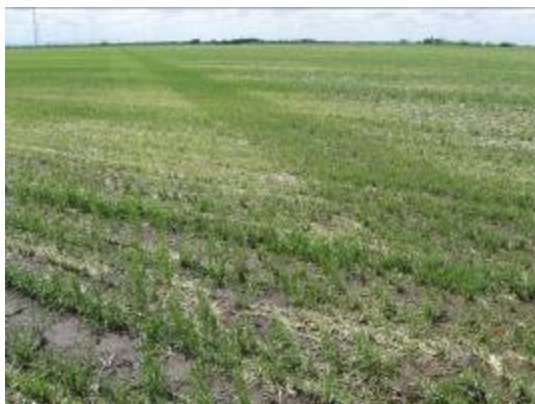
This cropland field in Thayer County was protected by a cover crop when Wednesday night's storm hit. The cover crop helped the heavy rainfall be absorbed into the soil and prevented erosion.

In Hebron, where over 10 inches of rain was recorded after Wednesday's storm, NRCS Resource Conservationist Aaron Hird saw first-hand how residue cover can make a big difference in the way a field handles heavy rainfall. On two adjacent fields, one field had a cover crop growing on it and the other field was conventionally tilled. The conventionally tilled field had standing water on it while the field with the cover crop had very little water movement across the field and very little standing water. After such a significant rainfall, Hird was impressed to see what a difference a conservation practice can make.

“The water infiltration rate after 6 years of cover crops changed this field drastically! I can't believe that he (the producer) was able to infiltrate 10-plus inches over an 11 hour storm event,” Hird said.

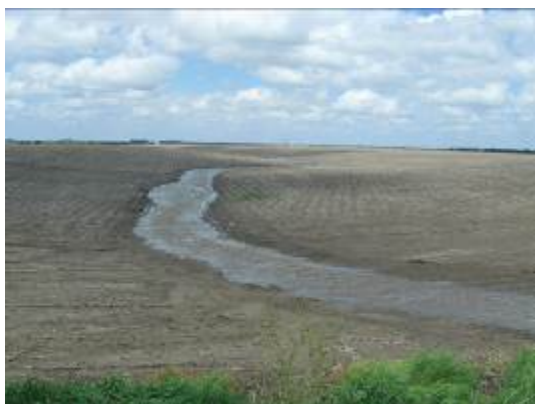
This cropland field in Thayer County was damaged by erosion following Wednesday night's storm.

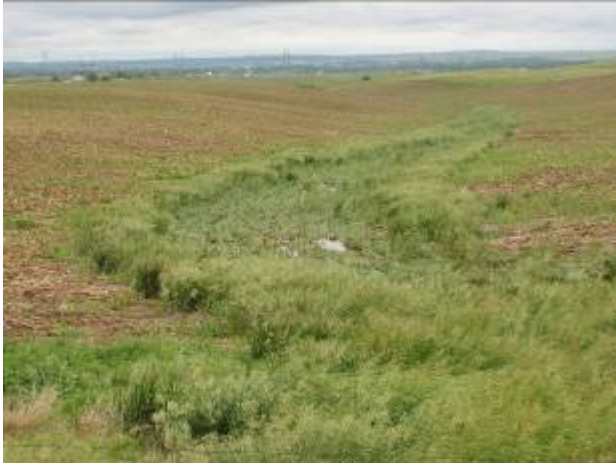
This waterway helps capture and slow water in concentrated points in the field, protecting the soil from erosion.

While flood control structures help hold back large amounts of water, everyday conservation practices applied to farmland can also play an important role in reducing runoff. Fields are especially vulnerable to heavy rains this time of year. Residue left over from last year's harvest will be broken down and not provide much protection. But conservation practices like terraces, buffer strips and waterways help keep runoff from cropland to a minimum.

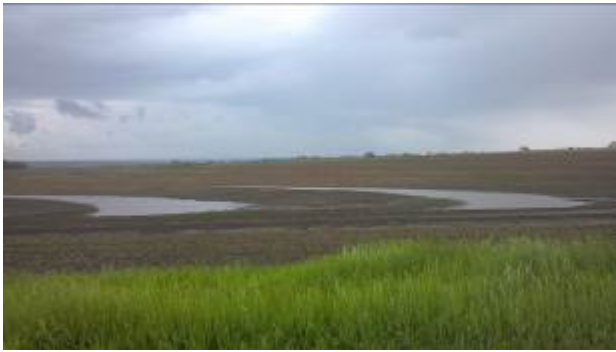
Terraces capture water after heavy rains and holds the water until it can be absorbed into the soil. This prevents soil erosion.
