## **Santa Monica Debris Basin Prevented Major Damages from Occurring After Heavy Rains in Wild fire Burned Areas in California.**

### Santa Monica Debris Basin

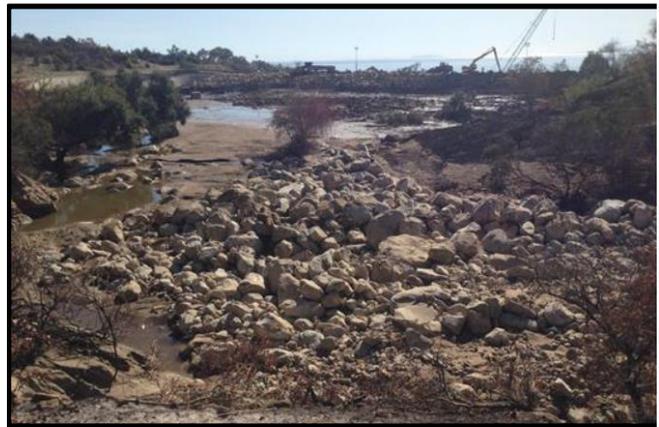
Boulder field in Santa Monica Creek at the debris basin inlet after January 2018 rains

This debris basin was tested “to the limits” in early January 2018 when it completely filled with debris, sediment and huge rocks that was washed from the burned over watershed by a heavy rain storm.

Santa Monica Creek Debris Basin is an engineered facility that was built in 1977 as an element of the Carpinteria Valley Watershed Project. The debris basin was designed to trap 208,000 cubic yards of flood debris and was completely filled with debris after the January 2018 storms. Local officials with assistance from the Federal Emergency Management Agency and the US Army Corps of Engineers responded rapidly in cleaning out the debris from the basin restoring its capacity to trap additional debris during the spring rains.
