Warm Springs Run Site 7 Seepage Case History

Warm Springs Run Site 7

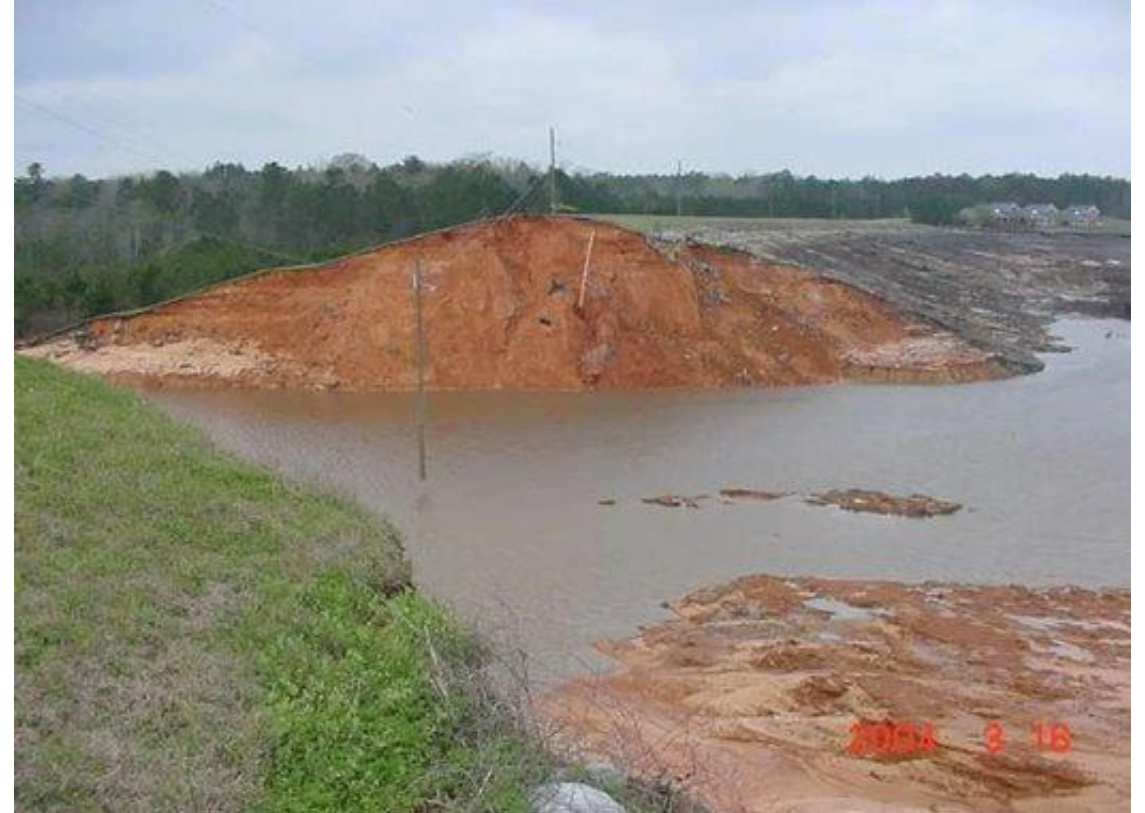
Big Bay Lake Dam

- 60-70' tall earth dam built in 1990
- A ½" diameter hole flowing 1 gpm became an 18" hole spouting 2-3' in the air in only an hour
- Just an hour and a half after the initial seep was discovered, the dam breached and an uncontrolled release of water started

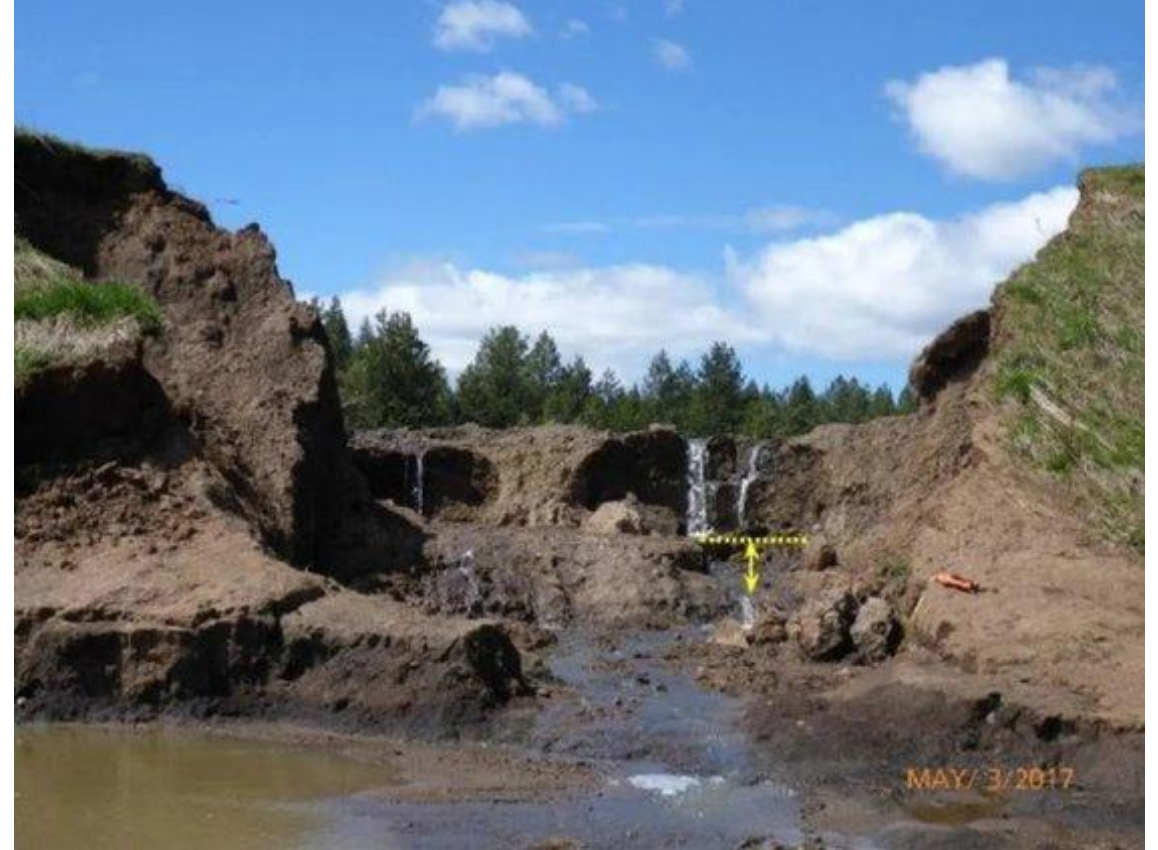
Bonasa Breaks Ranch Dam

- 19' tall, 414' wide stock pond dam with a 4.3 acre pool
- In 2010, a 5' deep depression near the future breach was regraded and no further action taken
- On April 13, 2017, the dam breached, causing flooding, erosion, and debris buildup downstream

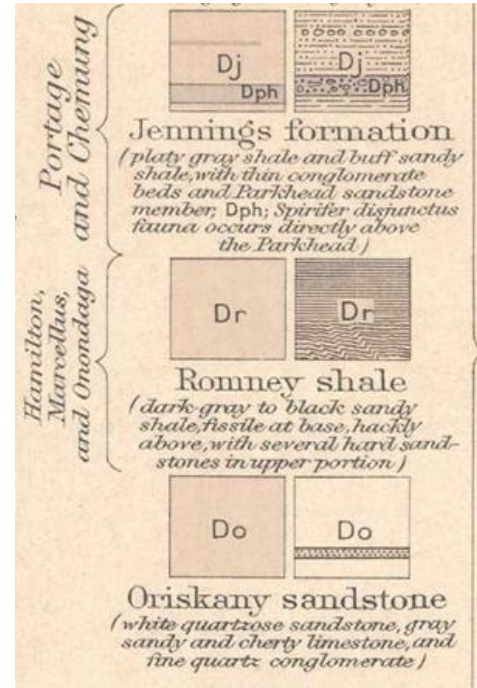
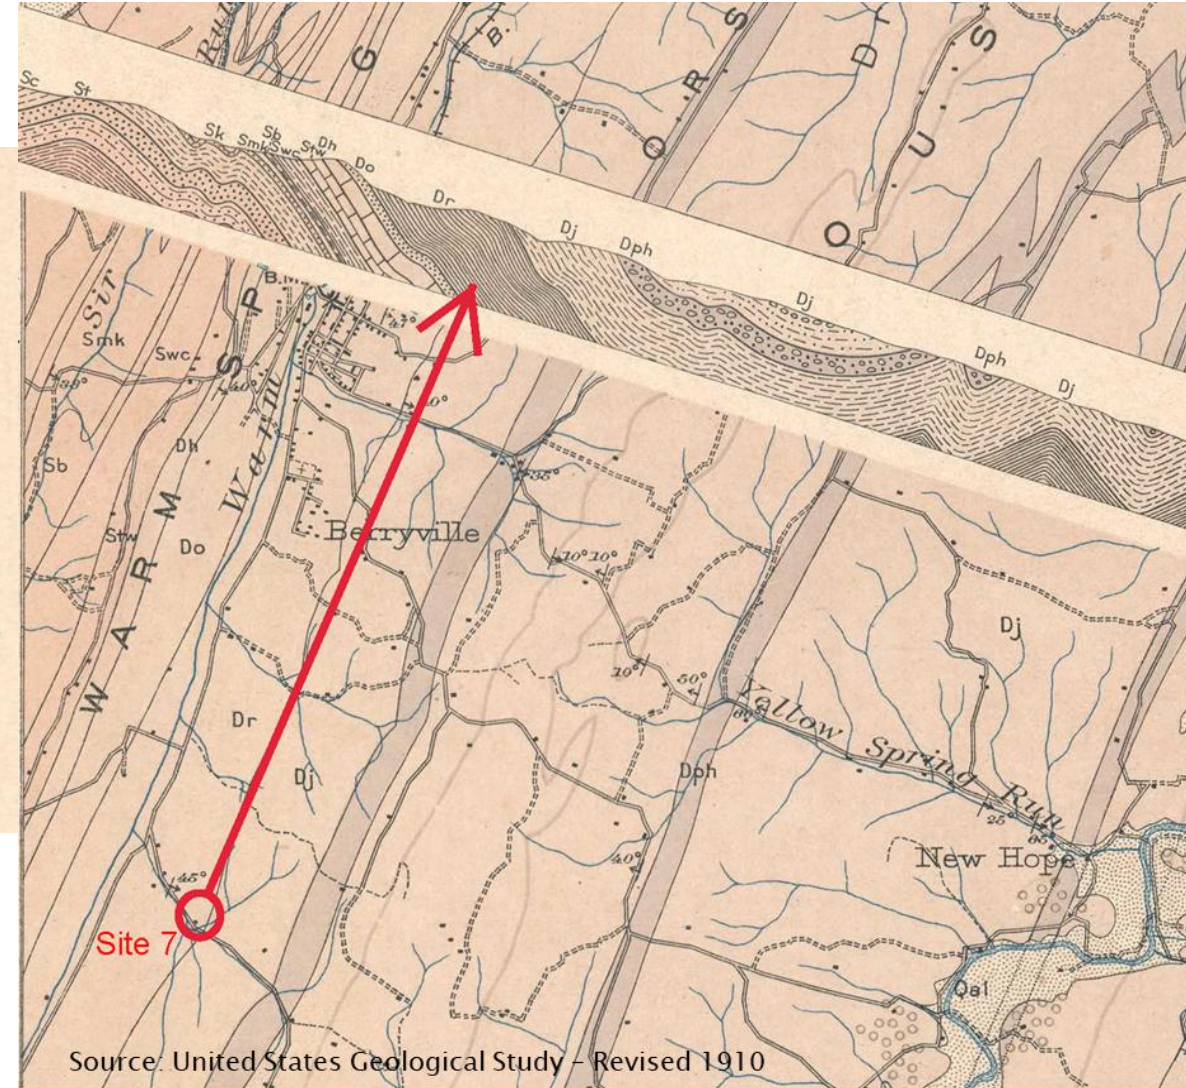
Geology

- Bedrock at the site consists of the Romney Shale in the Middle Devonian Group.
- dark grey to black sandy shale with sandstone inclusions; weathers to yellowish green with reddish stains
- Rock dips nearly 45 degrees to the southeast; Synclinal axis plunges approximately 12-15 degrees to the north-northeast.

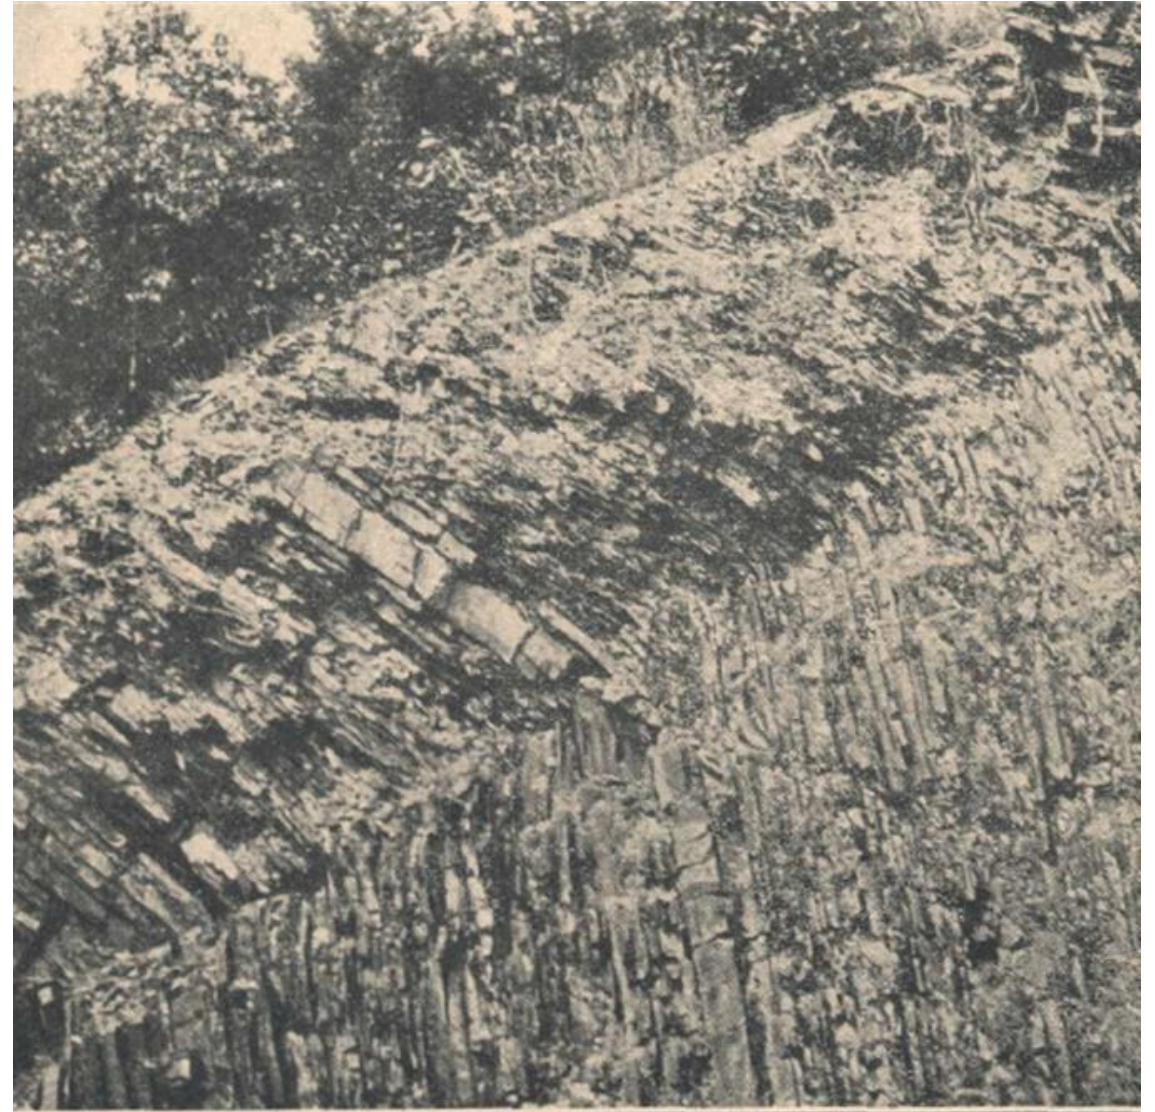
Geology

- Extent of Thick Shale Formation, Difficult to Escape from the Conditions.
- Highly Variable/Unpredictable Weathering
- Varying Permeability
- 45° to Near Vertical Varying Bedding of Rock
- Variable Embankment Fill Composition
- Evidence of Water Passing Through Competent and Weathered Rock
- Shale Conditions Present Difficulties in Treating Bedrock With Confidence
