Upper North River Watershed Dam No. 10 Rehabilitation Project Augusta County, Virginia

Fact Sheet
April 2016

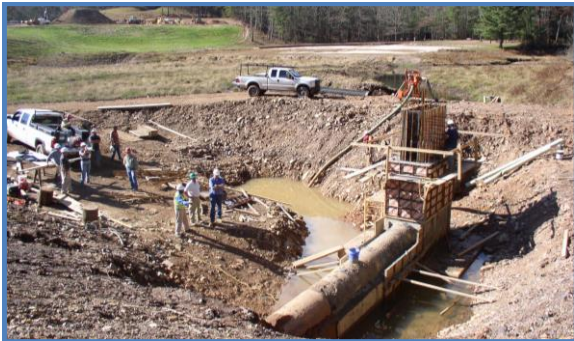
The concrete principal spillway inlet tower and gates were replaced.

The top of the dam was raised 2.7 feet with earth fill and reseeded. The auxiliary spillway was widened from 200 to 300 feet. The concrete principal spillway riser and gates were replaced with new materials.

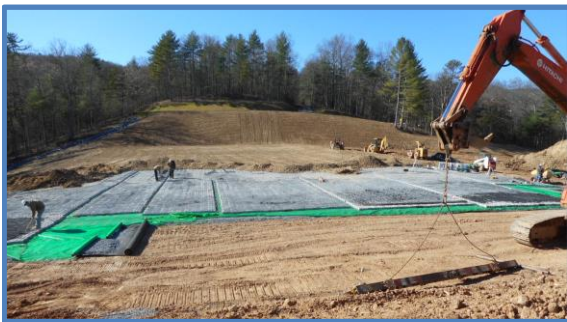
The control and outlet sections of the auxiliary spillway were covered with articulated concrete blocks to prevent surface erosion. The spillway was then covered with soil and seeded to hide the concrete blocks.

An 11.2 foot high concrete cutoff wall was installed at the end of the control section of the auxiliary spillway to prevent a dam breach. The control section and constructed outlet sections were covered with articulated concrete blocks to prevent surface erosion in the auxiliary spillway. The blocks were cabled together and completely covered with soil and grass so they are not visible. A rock toe drain was installed on the downstream toe of the dam.
